BRUSH CREEK RESERVOIR, JENNINGS COUNTY

NORTH VERNON MEETING
JANUARY 22, 2004

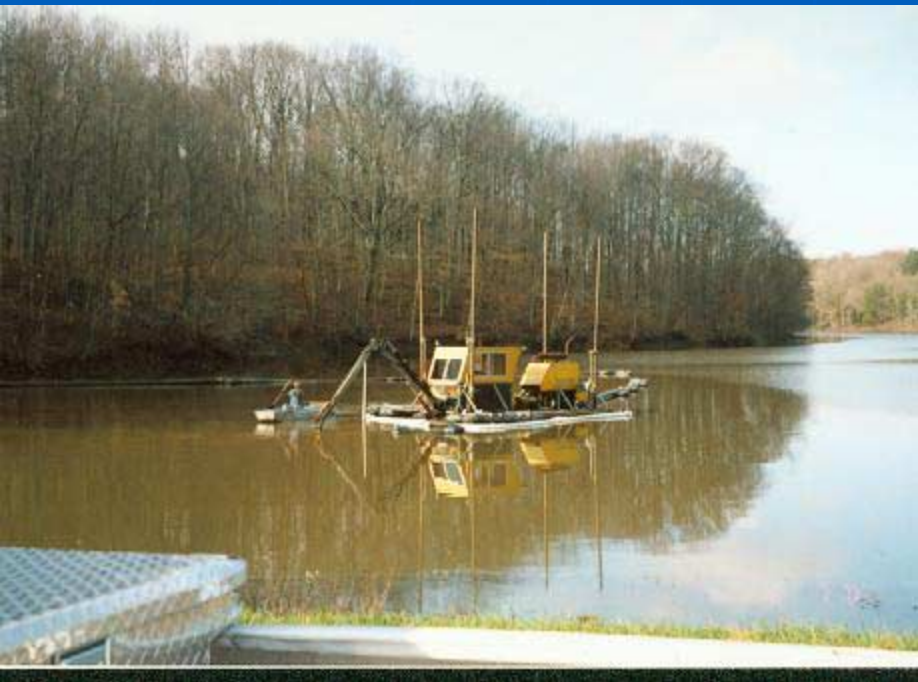
Public Access/Boat Ramp Dredging Project

High **sedimentation** rates have been documented.

Public Access Boat Ramp Dredging: Krevda, 2001

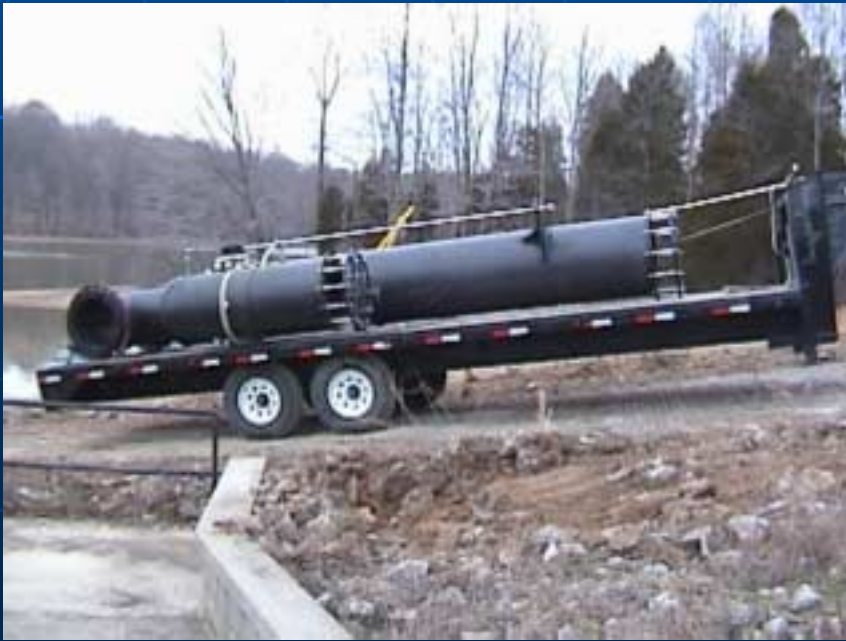
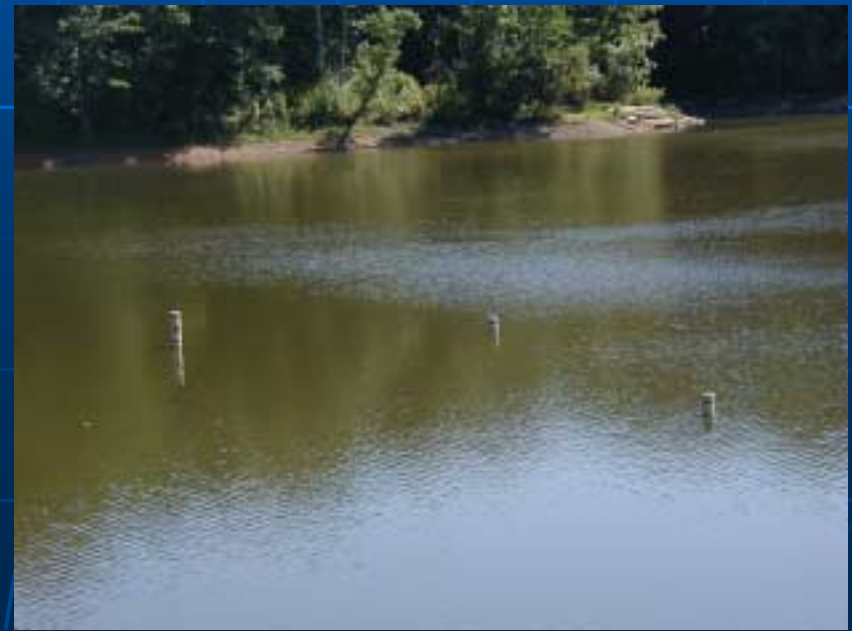
Outlet Pipe Location caused **taste and odor** problems.

Riser Pipe Installation: Mainstream Commercial Diving, 2003
